May 5, 2023

**Re: Department of Public Works
Review of Existing Trees and Recommendations
Location: 1 Allen Street, Fair Haven**

Department of Public Works
Existing Trees and Recommendations

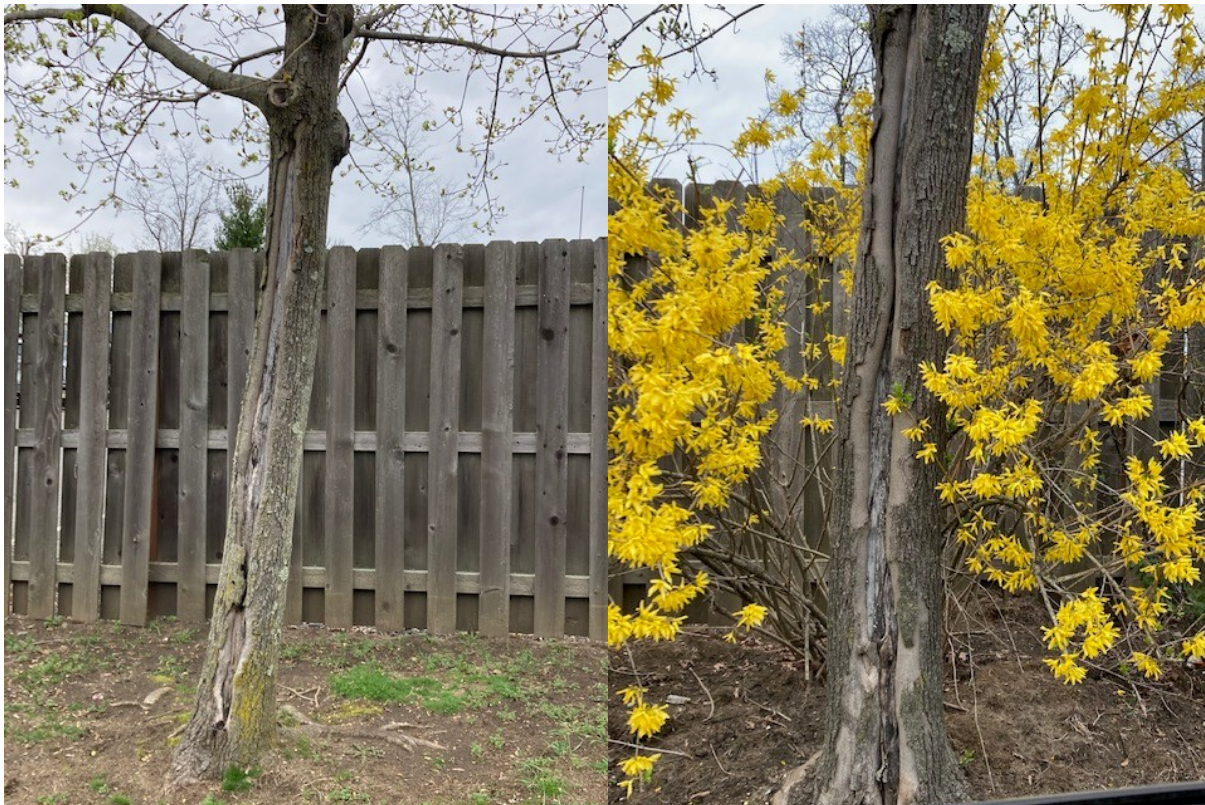
Four (4) Norway Spruce trees line the street between the property fence and the curb line of Allen Street. This is an invasive species prone to girdling roots, trunk decay, verticillium wilt (bacterial infection), and overall, dieback. These four (4) trees are in poor condition and exhibit many of these signs, as is typical of the species and one of many reasons why it is no longer utilized as in previous decades. While these trees are alive, they are in declining condition and will continue in this direction. Since upgrades are proposed for this area, it is recommended to remove and replant with higher quality species beneficial for area wildlife as well as for aesthetics.

Typical condition of Norway maple trees on Allen Street. Decay and decline will continue. Trees to be replaced.

The visual buffer desired for Allen Street should include replacing the shade trees. Consider Hackberry or Honeylocust, neither has leaves as large as the existing Norway maple trees, which should help in reducing leaf litter. To aid in buffering views with limited planting area, an upright Juniper tree, such as Hetzi Juniper or Wichita Blue Juniper, can be planted along the future fenced yard. These evergreen trees will not grow nearly as wide or tall as the typical pine and spruce buffer trees. Native and hardy shrubs along with ornamental grasses will help to break up the monotonous evergreen 'wall'. Bayberry, Arrowwood Viburnum, Beautyberry, Winterberry,

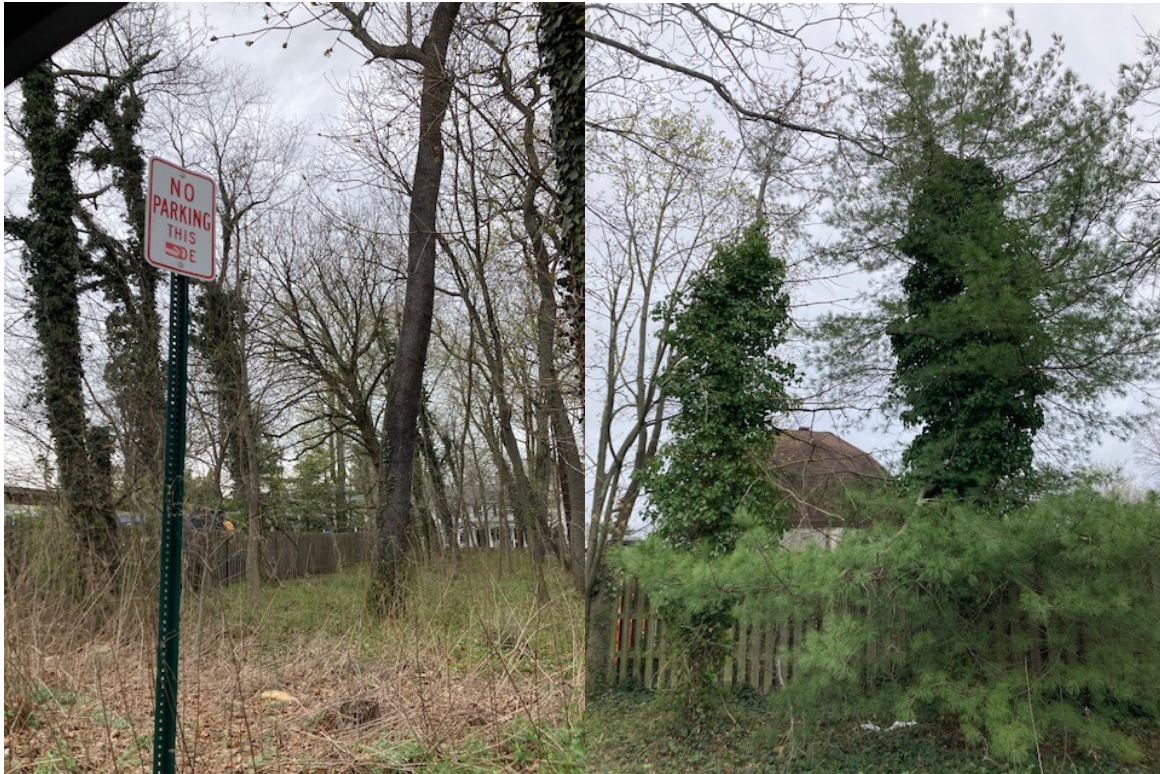
Further down the street, the fenced area ends and a wooded lot separates the Public Works yard from the adjoining residential property. It appears this lot had previously been cleared due to the species that has filled in this area, consisting of almost all Black Cherry and Norway Maple trees. English Ivy, another invasive species, has also established along the edges of the wooded property, especially along the back-fence line, climbing into the trees' canopies.

English Ivy outcompeting the trees

As previously mentioned, English Ivy should be removed from the canopies of any trees to remain. Within the wooded lot, minimal disturbance is recommended to prevent another unwanted species from colonizing the space. If a passive walking path is desired, a thick layer of arborist wood chips can be used for delineating a pathway.

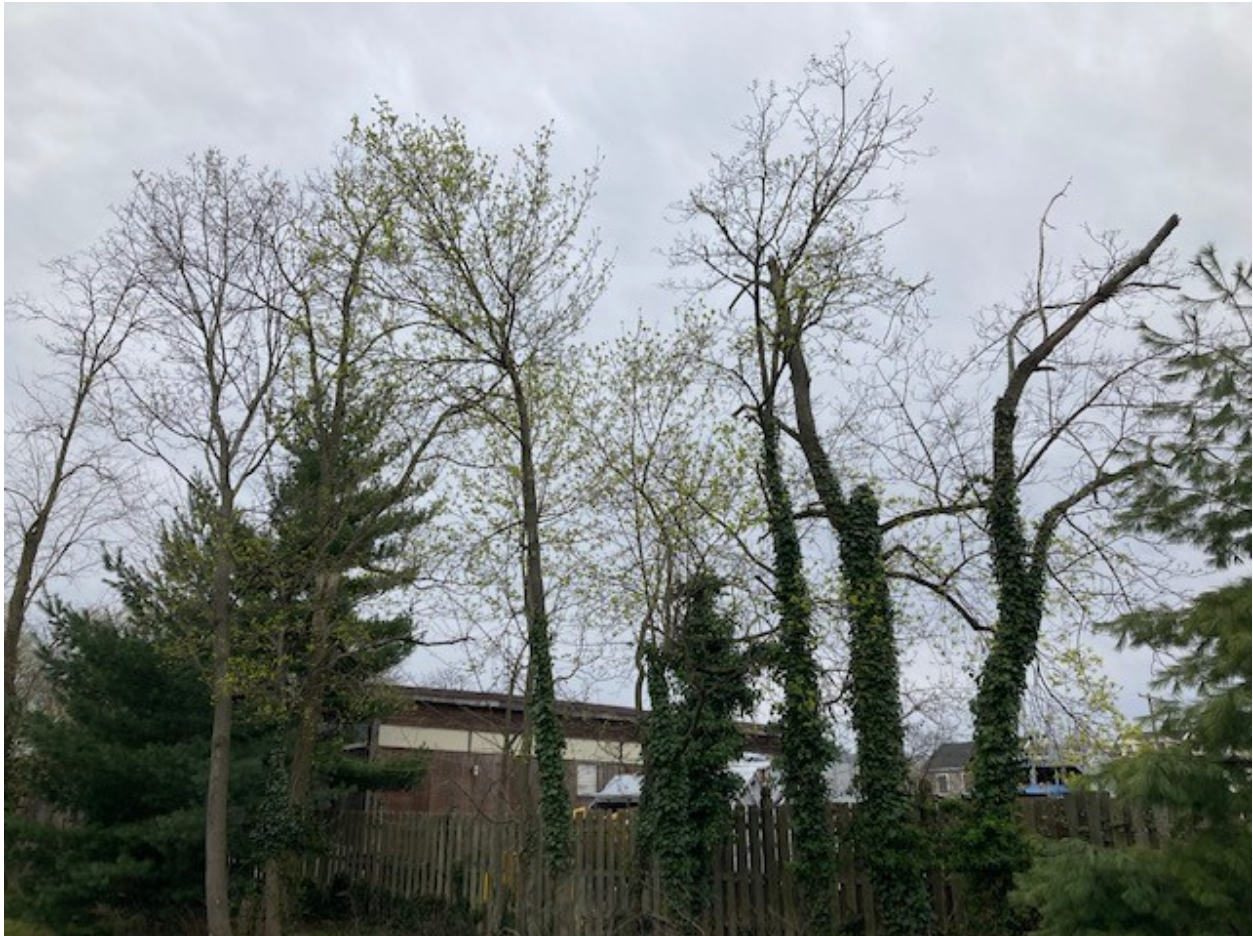
There are three (3) Black Locust trees near the corner with 3rd Street that should be removed due to their hazardous condition, missing canopy and decay throughout the trunk. Nearby, a group of young Norway Maple trees are in fair to poor condition with decay and dieback in the canopy and are being strangled by English Ivy. This grouping is located across from House #107. These invasive trees should be removed and replanted with native species. Ivy should be removed and the area should be monitored to prevent the vine from taking hold.

Pocket of Norway Maple trees covered in English Ivy, with decay and dieback. To be removed and replaced.

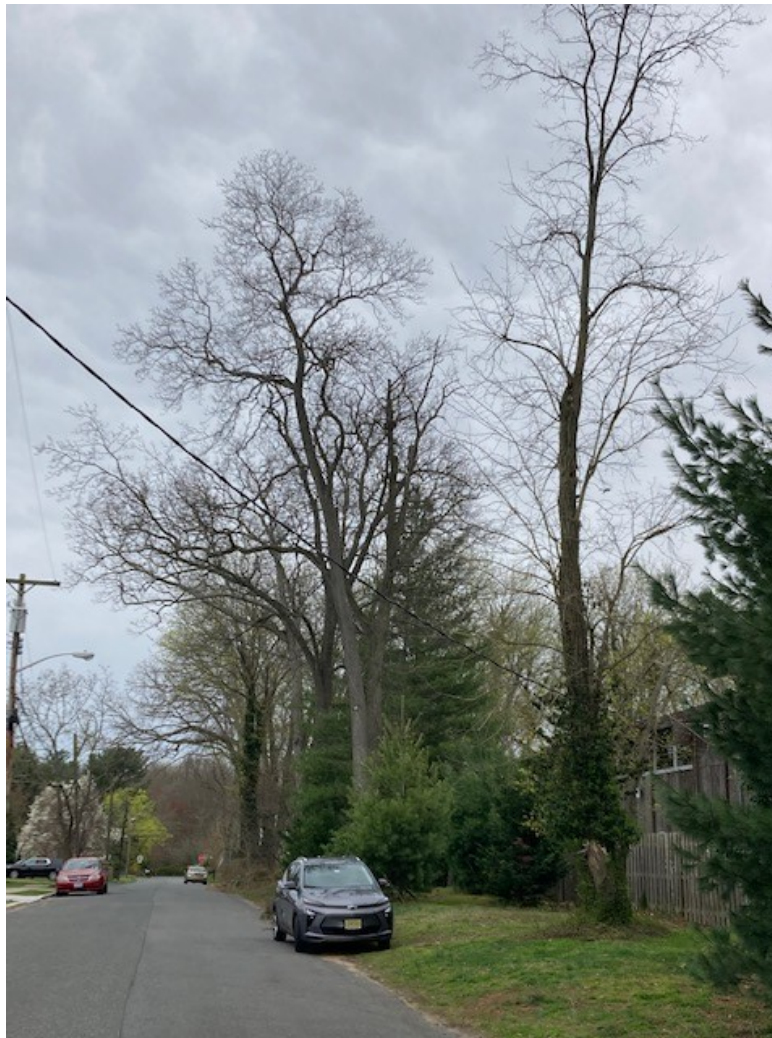
Continuing down Maple Street, there is a hazardous Black Locust that should be removed as well as two (2) large Hickory trees both with dieback and decay in the canopy and base of the trees. It appears the Hickory trees are beginning to decline and should be considered for removal to prevent property damage prior to their failure.

Black locust to be removed with English Ivy at the base.
Hickory trees directly behind the parked gray car with decay.
