RE: Fair Haven Historic Preservation

Block 49, Lot 18 (39 DeNormandie Avenue)

Application to the Fair Haven Historic Preservation Commission

PLEAT RESIDENCE

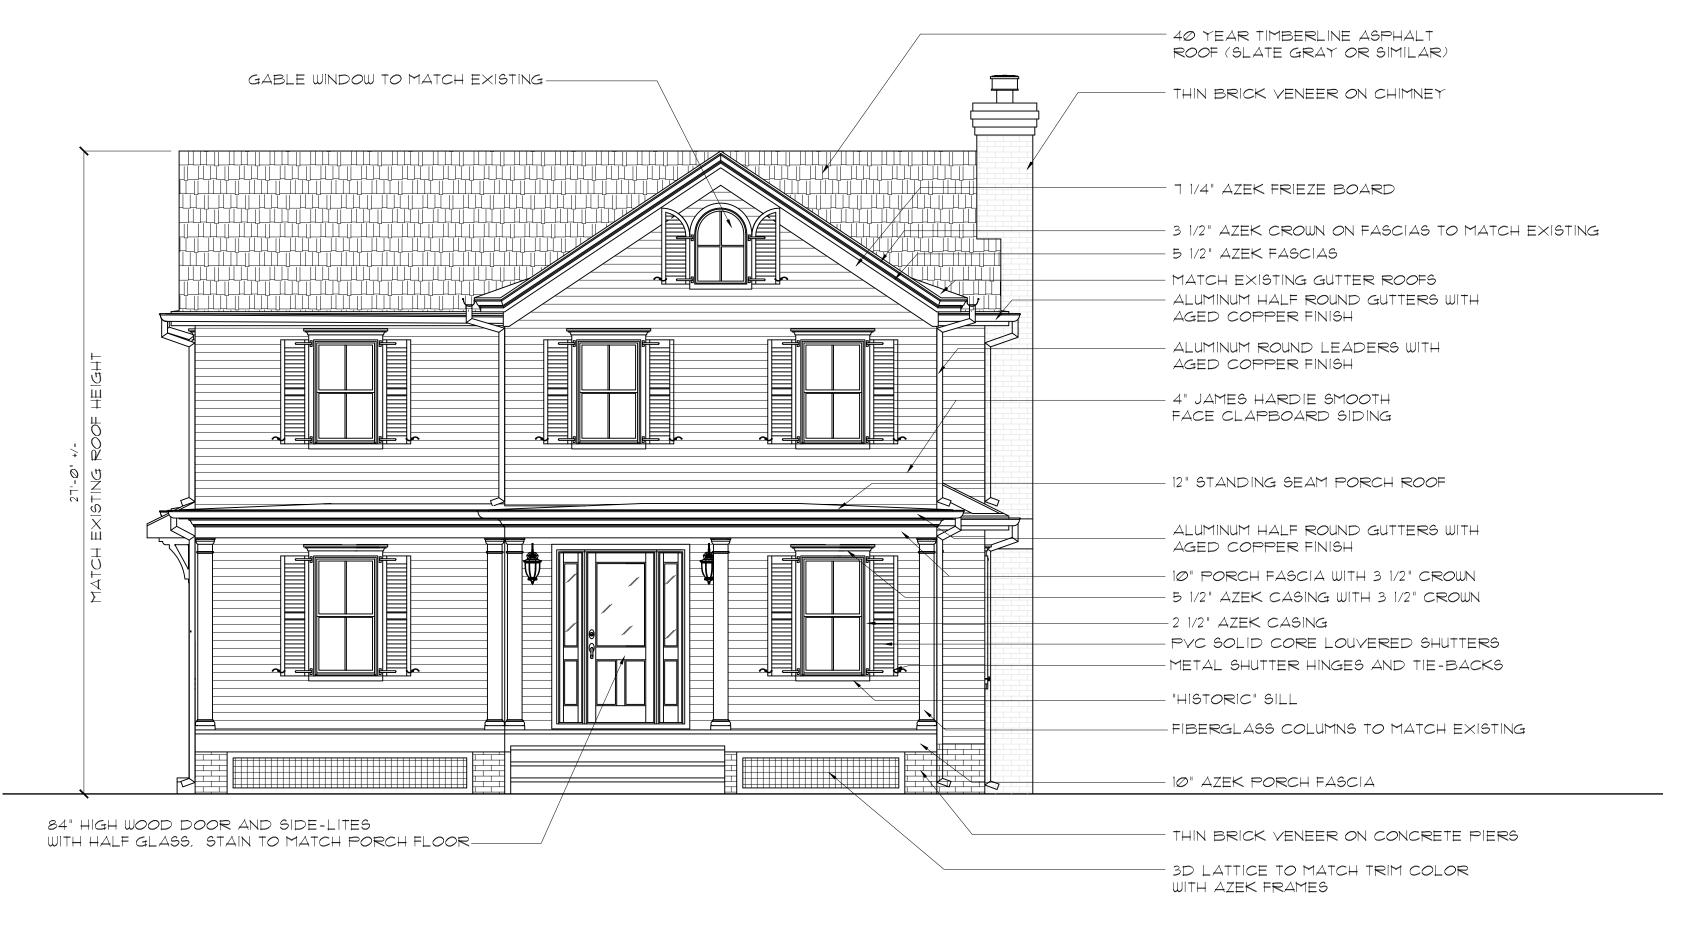
FRONT ELEVATION SCALE: 1/4" = 1'-0"

WINDOWS TO BE ANDERSEN "A" SERIES FIBREX "CANVAS" LIGHT FIXTURES TO BE BLACK POWDER COATED LANTERN TYPE AS SELECTED BY OWNER

PORCH SURFACE TO BE "AZEK" FAUX WOOD TONGUE & GROOVE PORCH CEILING TO BE AZEK TONGUE & GROOVE

- 1. Elevation drawings could incorporate specification of corner boards, which have not yet been indicated. Quarter round beaded detailing (where corner boards meet) are optional, but would bring an added historic element, often found on dwellings of that era.

- 7. Lastly, consideration should be given to the type of roof drainage system to be installed. It may have already be considered but is undiscernible from the reduced scale elevation drawings. A half round gutter system, with exposed hangers set at 24 inches on center, is recommended when restoring or reconstruction historic structures, where box gutters are not present. Downspouts should also be cylindrical to complement the suggested period style gutter.
